River Deben Association Saltmarsh Research Group

Saltmarsh Research on the River Deben

Researching the causes of saltmarsh loss

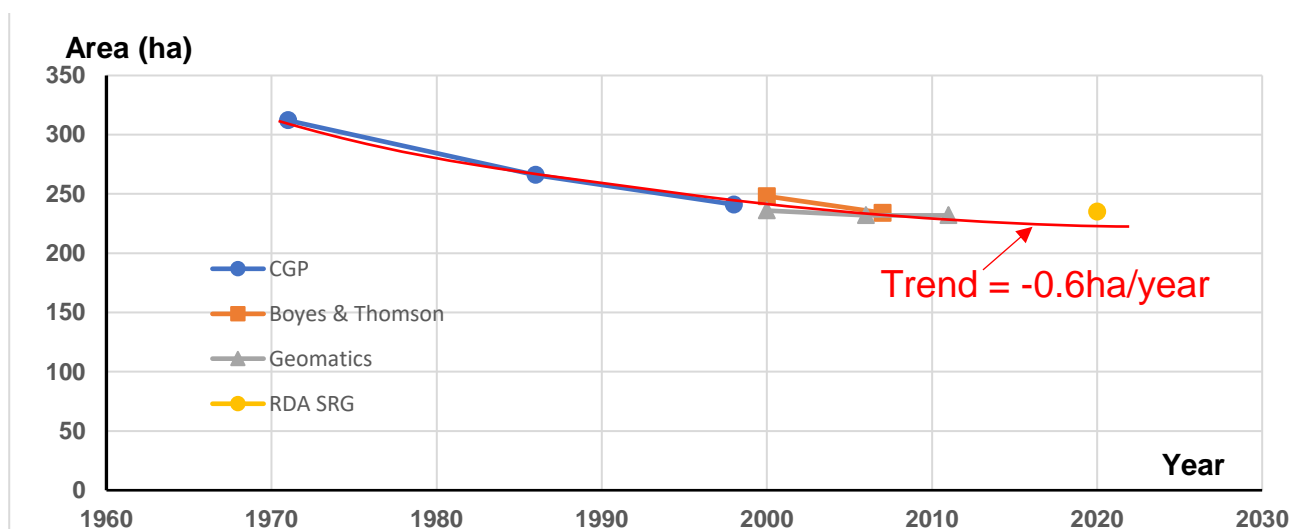
The Deben Estuary has a tidal area of 974 hectares (obtained from Google Earth) of which 235 hectares are classed as saltmarsh in 2020. Figure 1 shows the results of surveys from CGP⁷, Boyes & Thomson¹⁰, Geomatics⁹, RDA SRG. The current trend of erosion is at a rate of 0.6 ha/year.

Figure 1: Saltmarsh erosion

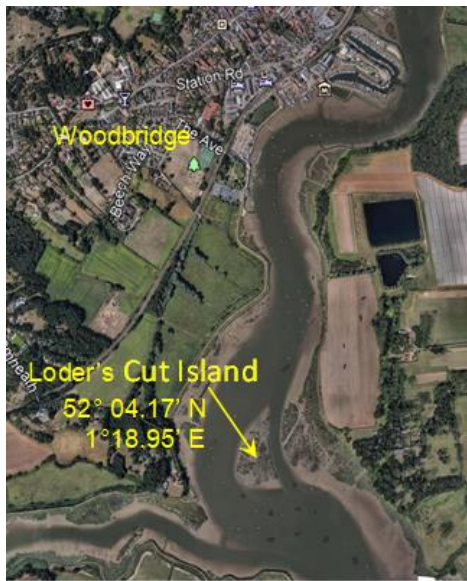
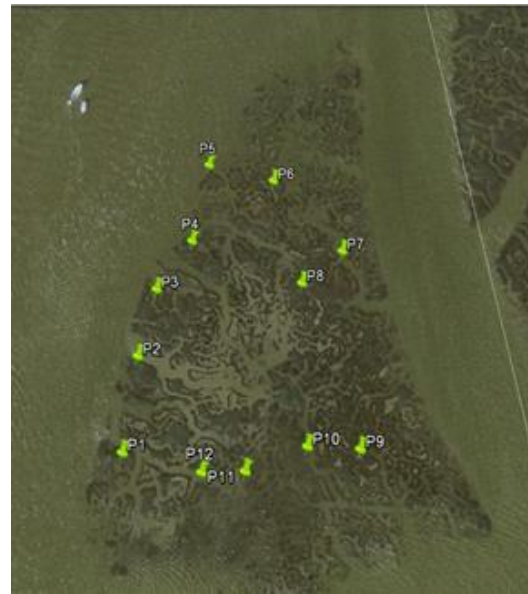
The cut is marked with 'withies' and is in continuous use by local and visiting craft, as an alternative to the main river channel. Monitoring of the saltmarsh started in September 2014 and measurements have been taken at six-month intervals. Figure 2b shows the layout of the twelve measuring posts.

Figure 2: Location of Loder's Cut Island and position of the twelve posts

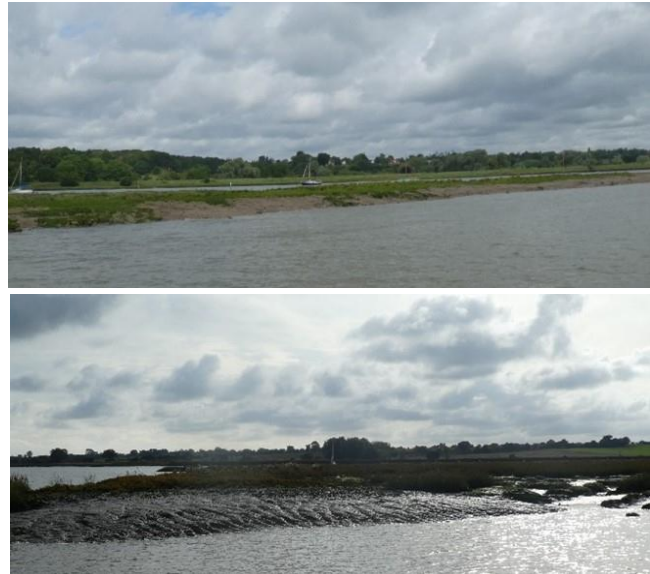
Apart from the survey work, an experiment has been carried out to place solid dredgings to regenerate saltmarsh. 750m³ of mud was dredged from the mud bank at Ferry Dock and the Deben Yacht Club in Woodbridge in 2015 (and further dredgings in 2017). This was transported by barge and placed at the north end of Loder's Cut Island. This has remained in place and allowed four different species of maritime plants to grow within a year. In 2016 the upper margins of this deposited strip had a thick cover of *Salicornia* spp. as well as occasional Sea Aster (6-7 plants) and one *Spartina* plant. There were also signs of bird feeding on the un-vegetated lower margins on the channel/cut side. Figure 3 shows the area in plan and photographs of the new saltmarsh looking from the east and north-west.

Figure 3: Plan showing new saltmarsh with photos from east (above) and north-west (below)

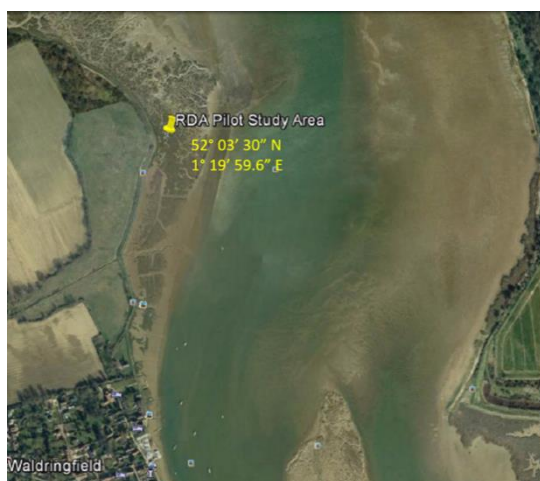
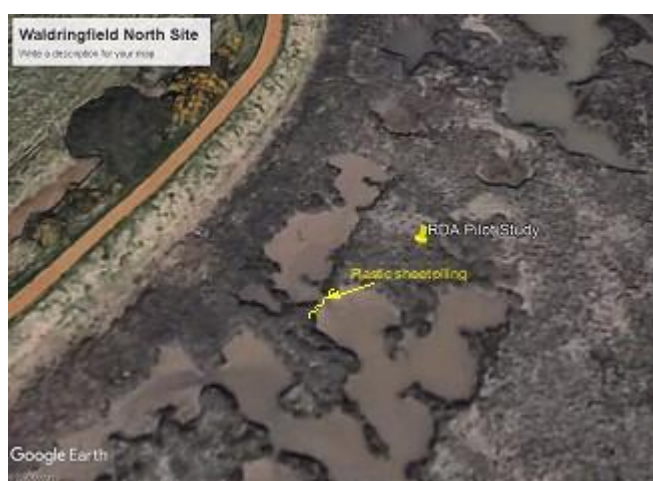
Figure 4: Location of Pilot Study Area north of Waldringfield

5.2 Saltmarsh Pilot Study at Waldringfield: This site is situated half a mile north of Waldringfield as shown in Figure 4.

a) General area

b) Local area

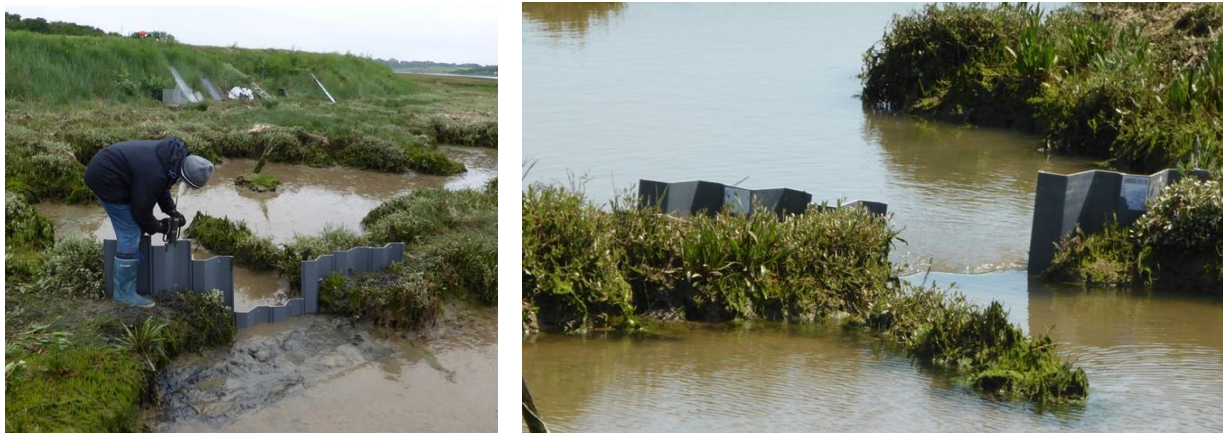
The purpose of the pilot study has been to measure changes in saltmarsh level, the erosion at the edges of the saltmarsh and investigate the role that shore crabs and ragworms may have in these changes. Crab exclusion cages and ragworm exclusion plates have been used to assess the effect of crab and ragworm bioturbation on drainage channel sedimentation. In addition, a method of increasing sedimentation in drainage channels using a sill has been investigated. Figure 5 shows the sheet piling (Linlar Std Pile Grey) used to create a sill across a drainage channel. The length of the sheet piles is 1.5m and they have been extended horizontally 0.5m into the saltmarsh to prevent leakage around the ends. The sill is set at 200mm below the level of the saltmarsh.

a) Installing the sheet piling

b) Sill created by sheet piling

Figure 5: Placing of plastic sheet piling across a drainage channel

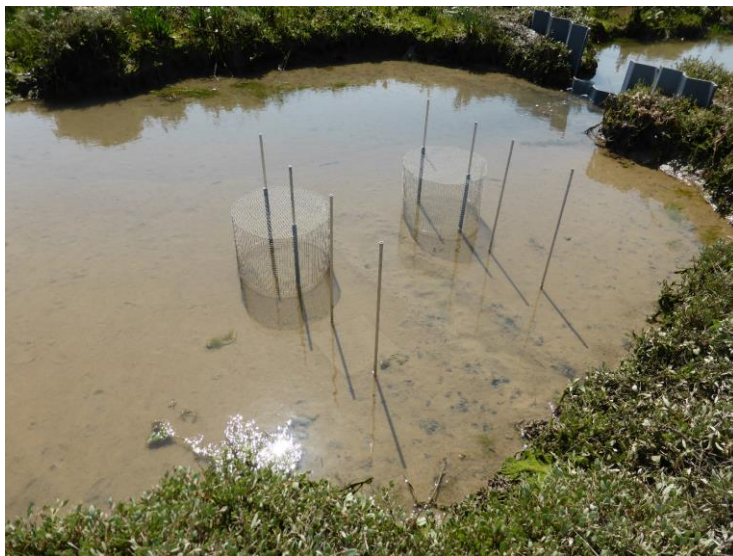
- i) A control area with an open natural mud surface
- ii) A crab exclusion cage. The original galvanised mesh cages corroded after four years and are being replaced with plastic coated galvanised mesh cages.

- iii) A 300 x 300mm perspex plate to exclude ragworms. This is laid on the surface and pegged in opposite corners with two 0.5m aluminium rods.
- iv) A combined cage and plate to exclude both ragworms and crabs

Figure 6b: Arrangement of equipment for measuring change of level of mud

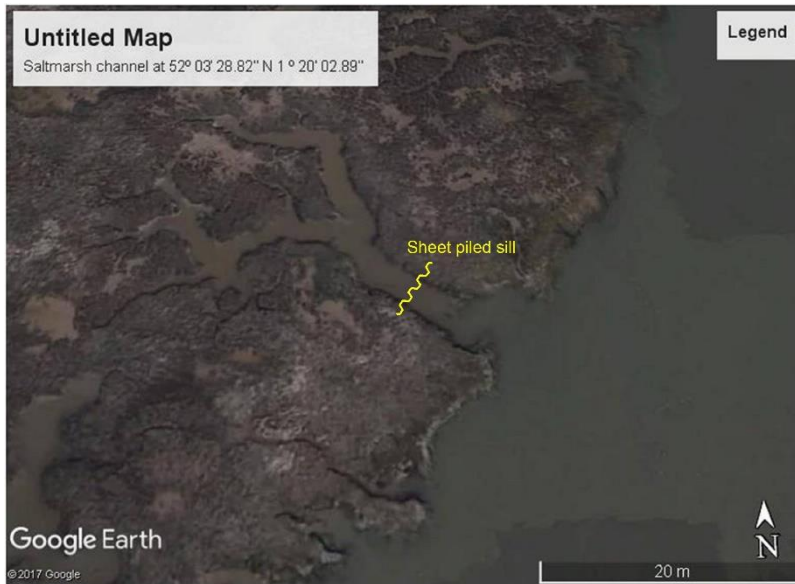
In 2018 the work was extended to include a second plastic sheet pile wall closer to the river channel (see Figure 8), placing more sticks along the edge of the saltmarsh, and the introduction of crab exclusion netting (see Figure 9 &10). 19mm Diamond Mesh Anti-bird netting.

Figure 8 Location of the second plastic sheet pile wall

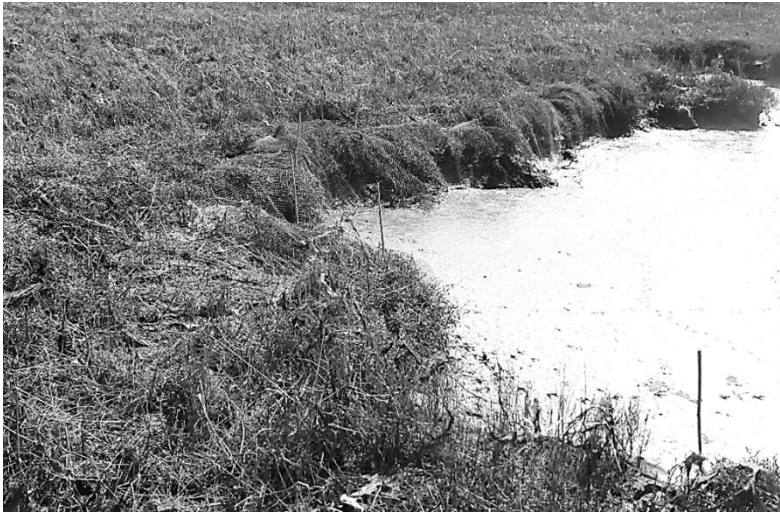
Figure 10: Placing of crab exclusion netting

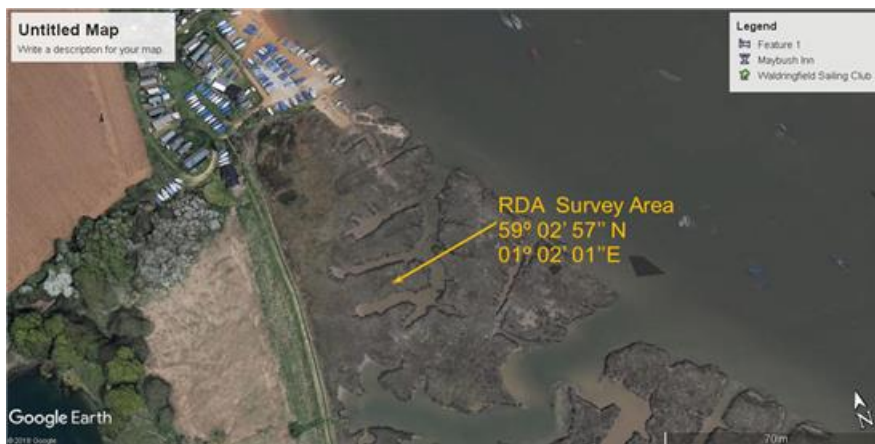
Figure 11: Location of the extension site

5.3 Extension to saltmarsh Pilot Study at Waldringfield: An application to extend the survey to a site south of Waldringfield (see Figure 11) was made to the EA and MMO in November 2018.

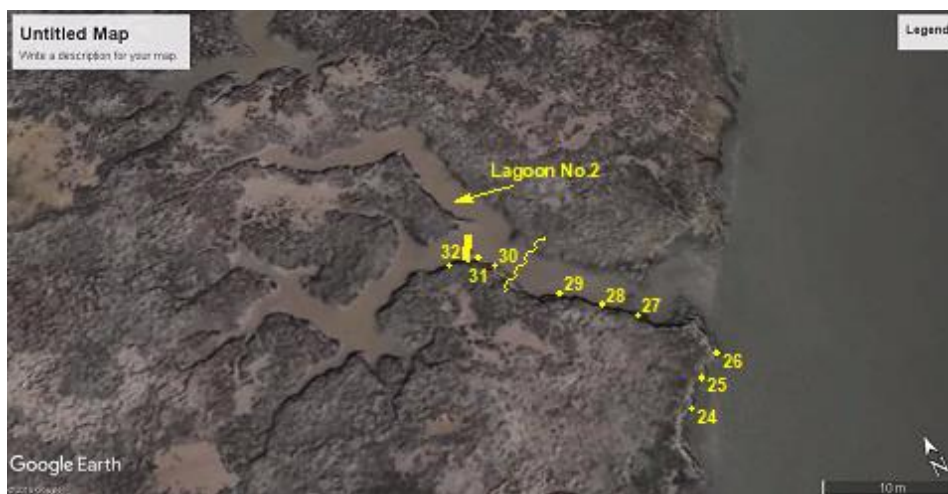
Figure 13c: Layout of measuring equipment north of Waldringfield

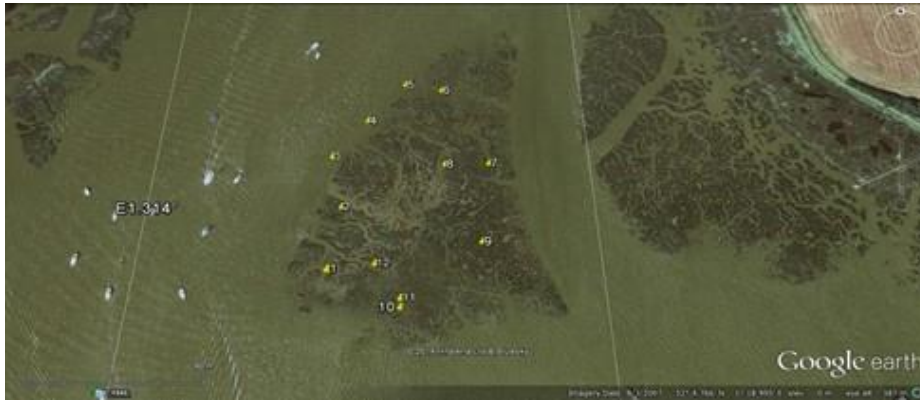
Figure A1. Google earth aerial image showing location of posts on Loder's Cut island (plotted from co-ordinates obtained by River Deben Association).

Note: Post 10 was not accessible for survey but viewed from approximately 2 metres away. *Spartina anglica* was the dominant vegetation around the base.

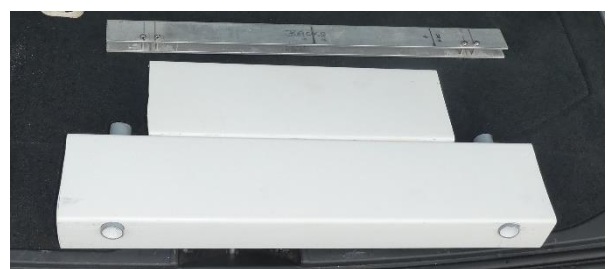
Where the mud lies below the water level the measurement gets distorted and a 220mm trunking spacer is used to allow measurement to be taken above the water line (see Figure B2).

2a) Cross section

1b) Levelling channel and trunking spacer

Figure 2: Measuring the level of mud under water

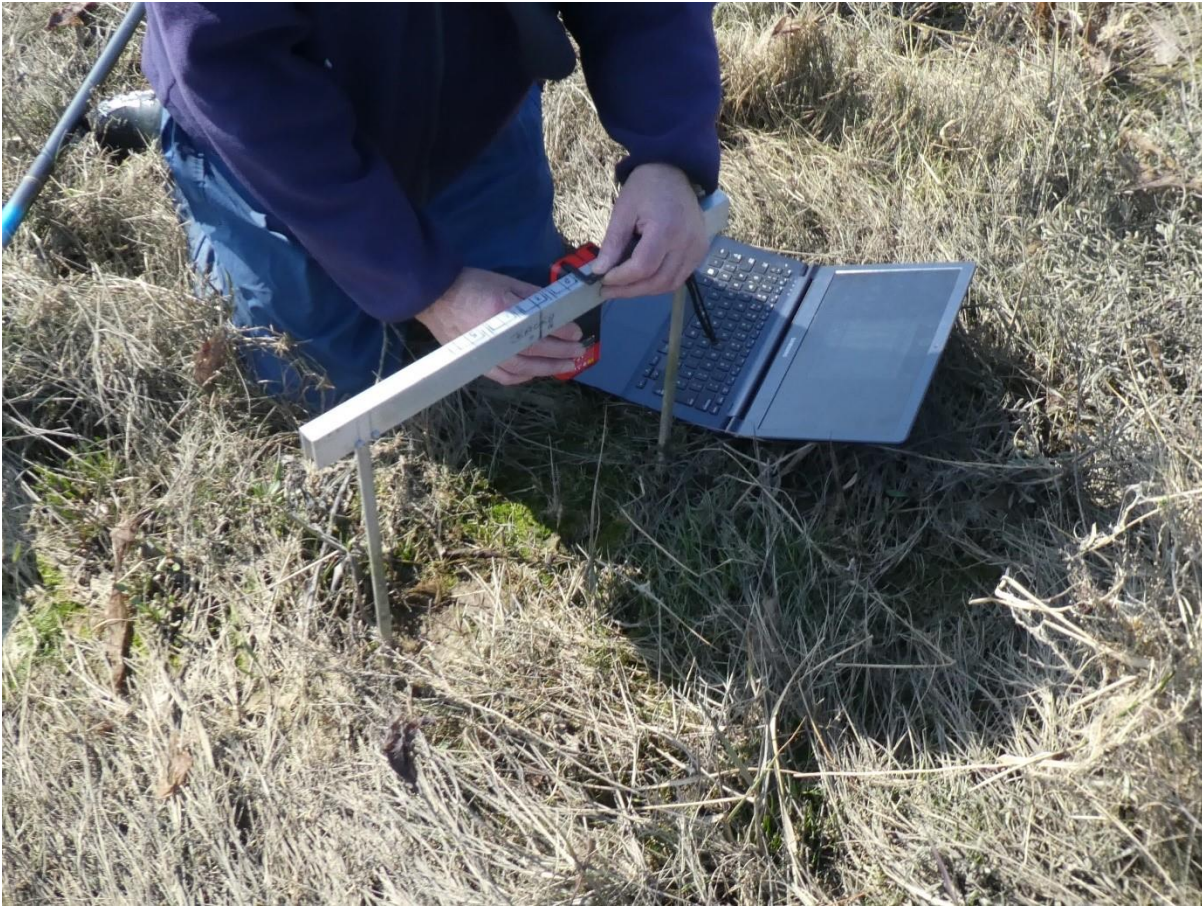
Aluminium Tubes $\frac{1}{2}$ " x 1.6mm x 2m (10 off /site)
 $\frac{3}{4}$ " x $1\frac{1}{2}$ " x $\frac{1}{8}$ " x 1m Ali Channel (2 off)

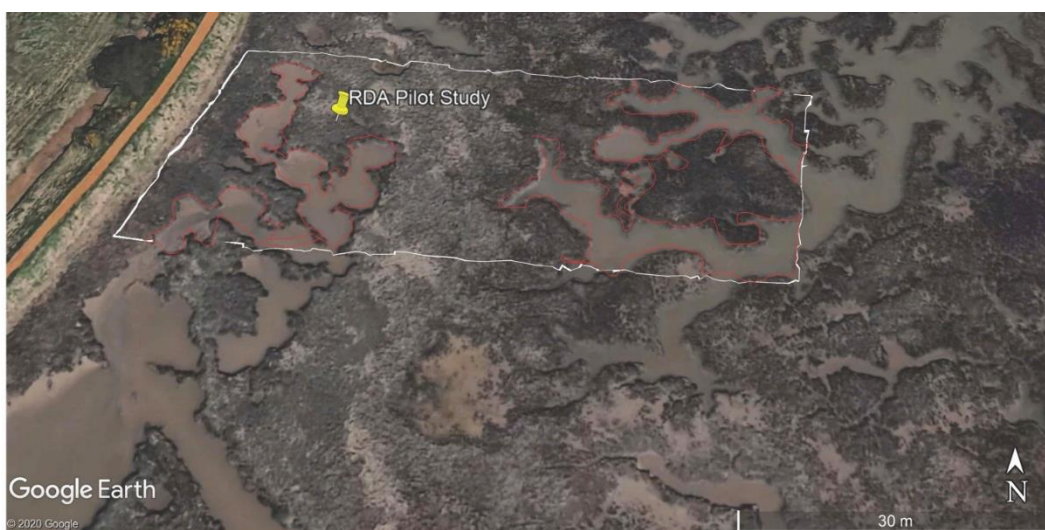
Area 2: Saltmarsh opposite The Rocks: Area = 1.19ha

Length of saltmarsh edge = 301 + 131 + 293 + 281 + 338 + 260 + 194 + 121 = 1,919m

Hence for 180ha Length is $1,919 \times 180/1.19 = 290,269\text{m}$

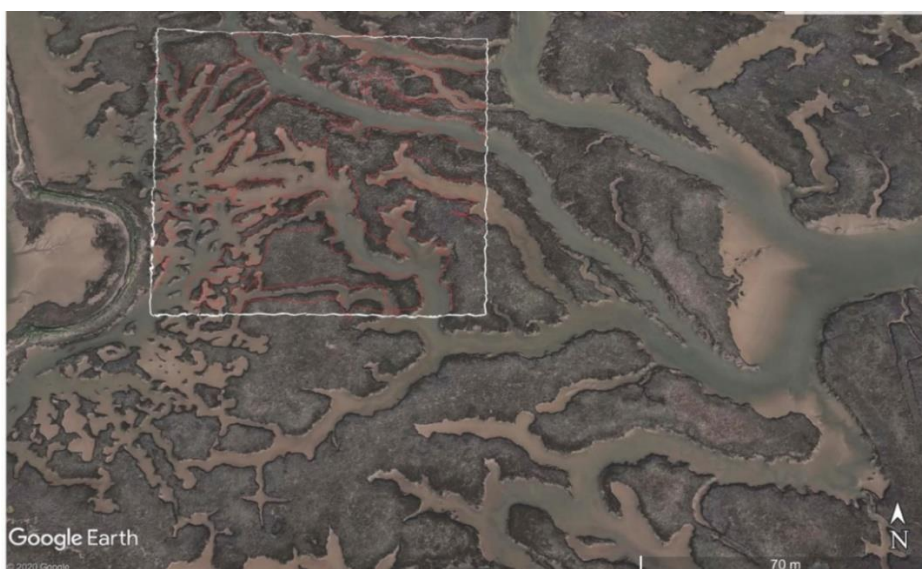
Area 3: Saltmarsh at Hemley: Area = 0.2ha

Length of saltmarsh edge = $130 + 274 + 23 + 23 + 24 = 474\text{m}$

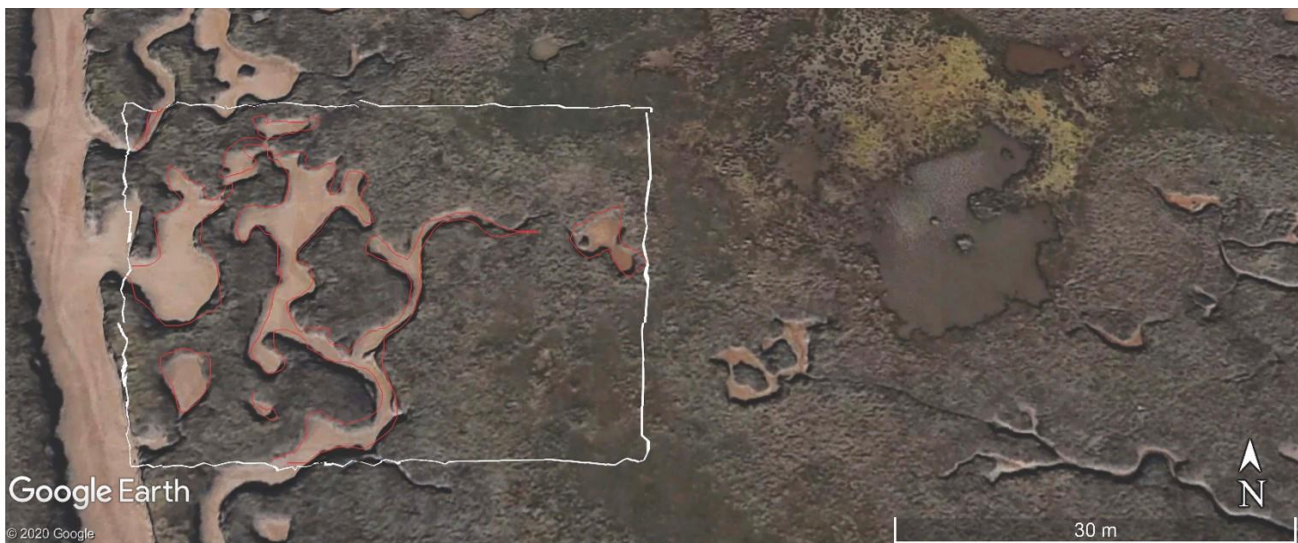
Length of saltmarsh edge = $21 + 186 + 44 + 15 + 6 + 15 + 10 = 297\text{m}$

Hence for 180ha Length is $297 \times 180/0.13 = 411,231\text{m}$
